A WEB EXCERPT FROM
THE OSTRACON
 THE JOURNAL OF THE EGYPTIAN STUDY SOCIETY

New Perspectives on the Interior of the Bent Pyramid

Charles Rigano

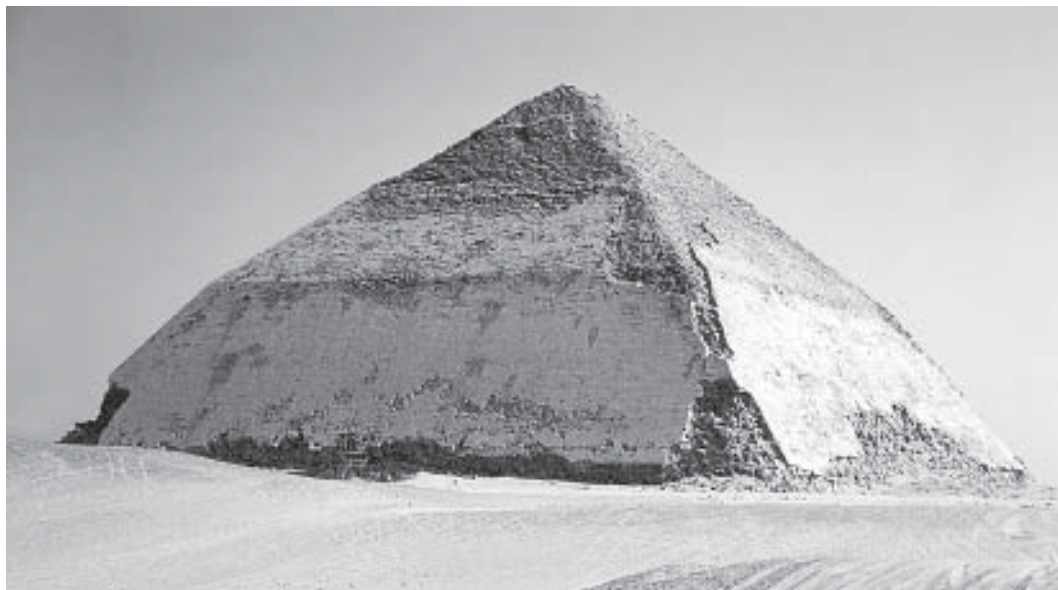
Figure 1: North (left) and west (right) sides of the Bent Pyramid. The 40-foot-high scaffold to the entrance is barely visible at the center of the north face. Photo by author.

A locked, heavy metal door protects the north entrance. The casing around the entrance is generally intact with the architrave virtually whole. The architrave is the largest casing block in the pyramid. Its location at the center of the north face would likely have drawn the attention of anyone who wanted to find the entrance. As with other pyramids, ancient robbers had found their way inside and removed everything of value. Just inside the entrance are holes high on either wall that Petrie proposed had held a bronze pivot which supported a hinged stone door. Since this arrangement would effectively limit the available entrance to half the passage height, I have never thought Petrie's proposal was persuasive, but Petrie did not have benefit of Fakhry's discovery that a single casing stone closed the west entrance.

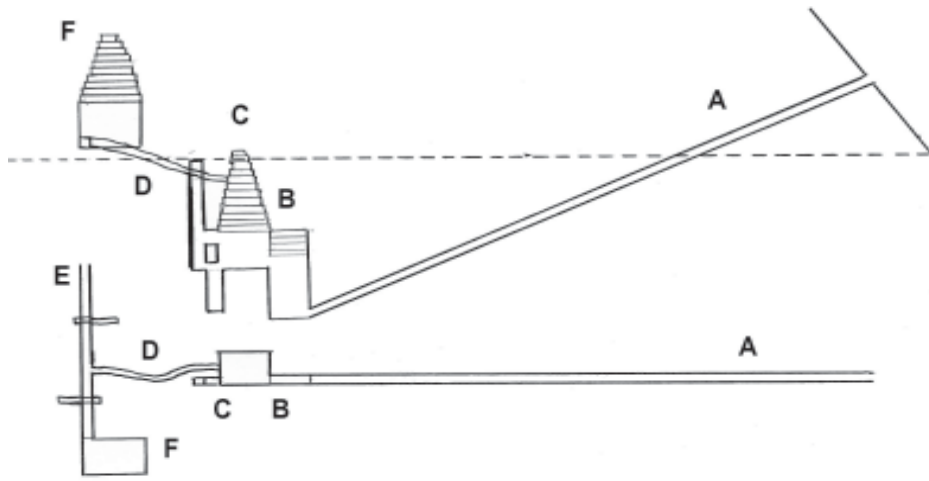
Figure 2. The internal layout as it appears today. The dashed line represents ground level. Upper drawing - looking towards the west. Lower Drawing - looking down. (A) Descending Passage, (B) Antichamber, (C) Lower Chamber, (D) Connecting Passage, (E) Upper Passage, F Upper Chamber

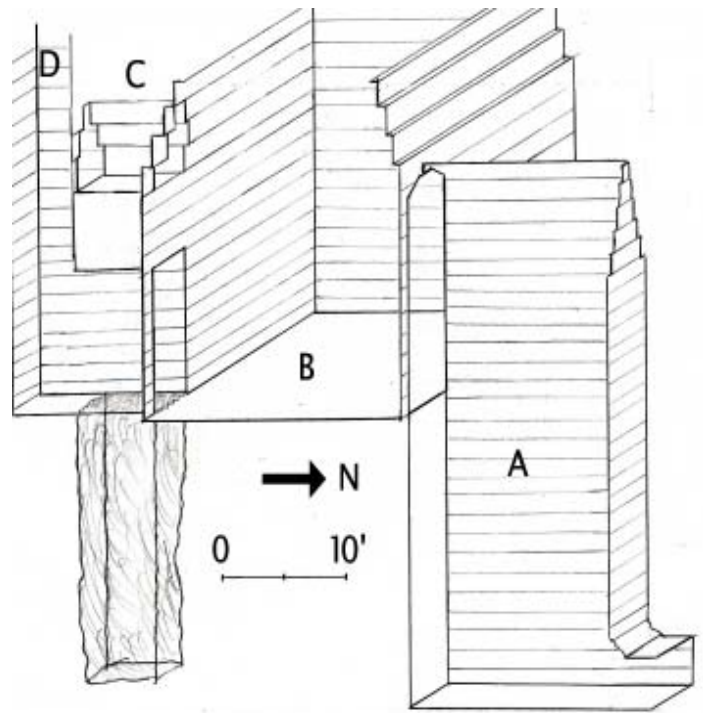
Figure 3: The descending passage enters the (A) antechamber from the bottom right. The scaffold (not shown) fills the west side of the (B) lower chamber. (C) windows, (D) chimney.

Opposite the entrance, on the south wall of the lower chamber, is a rectangular opening and short passage leading to the tall chimney. There is a squared hole in the short passage floor which workmen told Fakhry they had excavated to a depth of about 26 feet in 1948 without reaching the bottom. (Fakhry 1959:47) This hole is now completely filled with rubble. A corbeled window 18 feet above the chamber floor penetrates the wall between the chamber and the chimney and relieves the weight bearing down on the short passage ceiling.

The lower chamber measures 20 feet 8 inches by 16 feet 3 inches and rises to a 56 feet 9 inches high corbeled ceiling. The floor here is also littered with stone rubble that completely covers the surface, requiring us to walk carefully. Rubble is piled to a height of 5 feet along the south and west walls of the chamber. The chamber walls are not bedrock but are made of nicely laid limestone blocks. A section of the west wall is missing and the limestone lining can be seen to be about 1 foot thick.

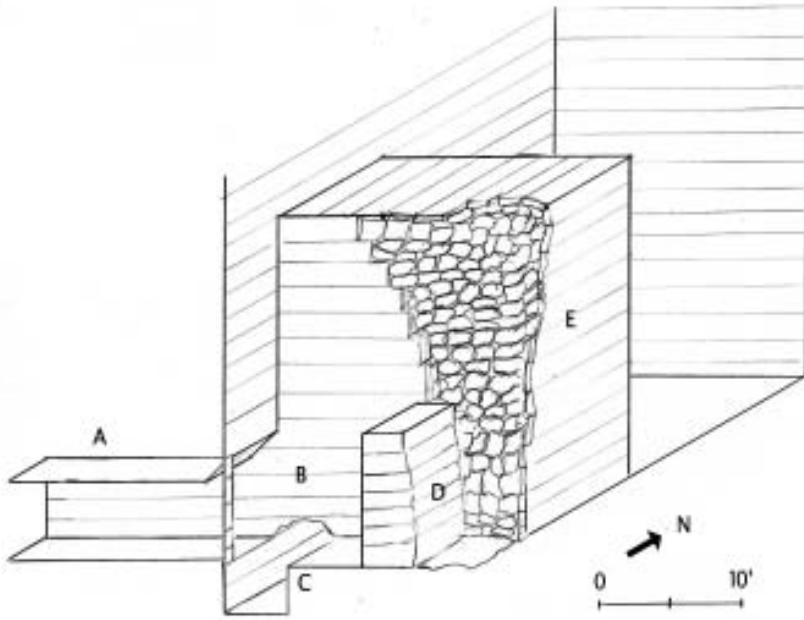
Figure 3: The upper chamber as it appears today. The cedar beams (not shown) are to the north of the massif. The Snefru cartouche is at the bottom east side of the trench immediately inside of the chamber. (A) upper passage, (B) small space, (C) cartouche, (D) short, (E) massif.

Based on reports and diagrams from earlier investigators, I had anticipated that the upper passage would provide direct access to the upper chamber. This was only partially true. Although the passage does lead directly into the chamber's southwest corner, within the overall 26 feet 2 inches by 17 feet 3 inches chamber, the small space that is accessible measures only 9 feet by 4 feet. My first impression was that I had not yet reached the chamber. However, a glance up at the 54-foot-high corbeled ceiling confirmed that this small space was in fact part of the upper chamber. To the left (north), the small space is bounded by a 21-foot-high vertical wall of well-cut blocks laid in courses. The east end of the wall is missing and roughly cut fill stones are visible. At the top of the wall's rough section,

long flat blocks sit on top of the rough stones and appear to indicate a floor. Maragioglio and Rinaldi described this large masonry mass of small limestone blocks, roughly squared and mortared, as a massif. (Maragioglio and Rinaldi 1964:70) To the front (east) is an 11-foot high short wall of similar quality to the left wall. This short wall is not flat but is well-cut, and mortared blocks projecting from the wall's bottom half indicate much of the original configuration is now missing. With some difficulty the short wall can be climbed. Over this wall is a space that reaches to the chamber floor and was probably excavated by early robbers. We had hoped to get over the massif to see the famed cedar beams which span the chamber. Climbing up the eastern, rough part of the massif looked possible, but dangerous. A slip here, deep inside the pyramid, could have had disastrous results and we decided not to risk it.

Just inside the upper chamber, robbers had cut a rough hole two courses deep spanning the floor and continuing under the left wall. On stepping down into this space, on the lower course we found an inverted cartouche of Snefru, drawn in red ocher, that confirmed the pyramid's owner.

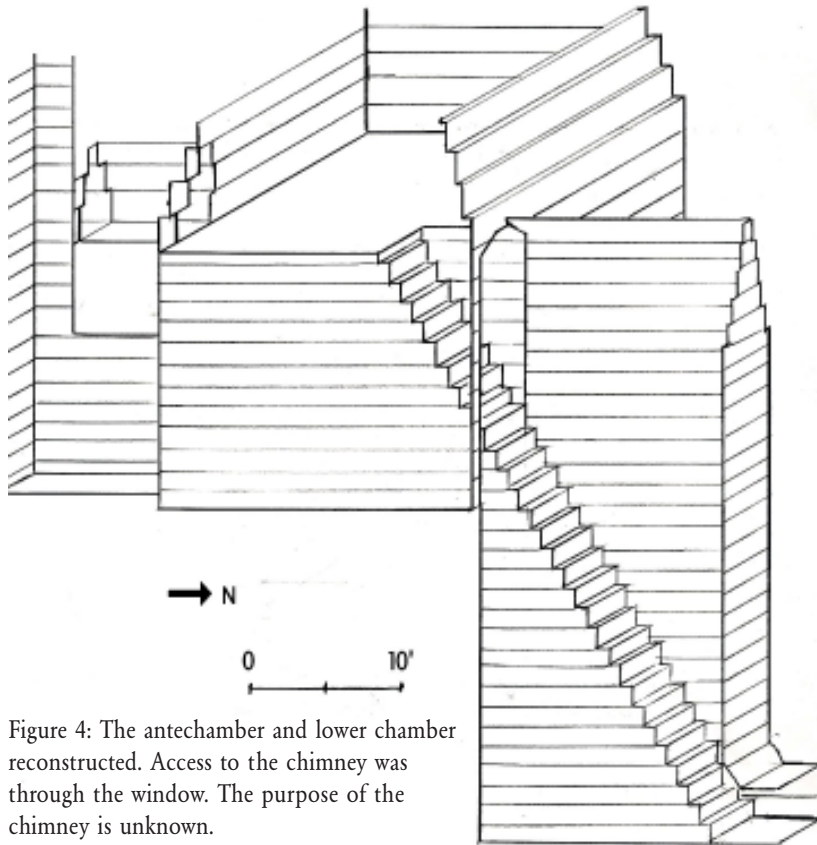
Figure 4: The antechamber and lower chamber reconstructed. Access to the chimney was through the window. The purpose of the chimney is unknown.

As noted earlier, marks on the side walls of the antechamber provide evidence that a staircase originally angled steeply upward from near the antechamber's lower entrance toward a point significantly higher than the present floor of the lower chamber. According to Maragioglio and Rinaldi, the mortar I saw on the antechamber walls exists only in the space which would have been covered by the staircase. (Maragioglio and Rinaldi 1964:62) Perring's drawing (Perring 1839:Plate XVI, Figure 2) shows that masonry, probably rubble from the destruction of the stairs, filled the antechamber to almost the first corbeled

Perring's drawings also show that the lower chamber contained a masonry fill. Fakhry reported that small squared blocks filled the chamber to the first corbelling, about 20 feet high. (Fakhry 1959:47) Maragioglio and Rinaldi suggest that the level was 3 feet lower at the base of the window. (Maragioglio and Rinaldi 1964:102) While we saw significant amounts of pink mortar on the east wall, Maragioglio and Rinaldi reported mortar on other walls as well, at times thick, up to the first corbel overhang. (Op. cit.)

This evidence indicates that originally a stairway ran steeply upward from near the antechamber's north entrance and provided access to the lower chamber, which had a floor about 17 feet above the current level. The presence of this staircase explains the apparently unnecessary height of the opening from the antechamber to the lower chamber - the lower half of the opening was filled by the staircase. It is likely that the small blocks forming the staircase were first shifted by robbers in their search for hidden spaces. Robbers also took apart the lower chamber floor and threw the debris down over the remnants of the staircase. With the intent of cleaning the pyramid interior, archaeologists removed most of the blocks and debris over a long period. The stones still littering the floors of both chambers and the debris piled against the south and west walls of the

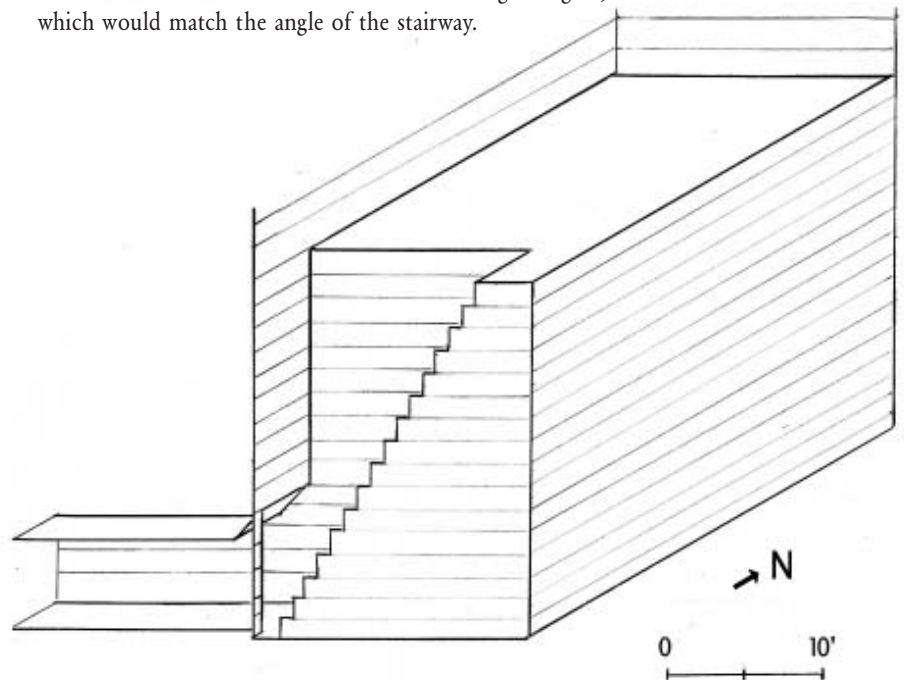
Figure 5: The upper chamber reconstructed. The cedar beam were buried within the massif which filled most of the chamber. A sarcophagus, if present, would have sat on the raised floor. At the chamber entrance the ceiling is angled, which would match the angle of the stairway.

Changes are also obvious in the upper chamber. Much has been made of the cedar beams spanning the chamber without a satisfactory explanation of their purpose. Perring found the upper chamber largely filled with the stone massif. (Fakhry 1954:510,512) Robbers had removed some the blocks in the northeast part and in the southeast corner, forming the shaft-like space we saw behind the short wall. In 1946 Hussein dismantled the northern part of the massif in search of Snefru's burial. As he removed stones in the middle of the chamber, the cedar beams became visible among the stones. He cleared the chamber's northern end to the floor level and exposed 10 beams composed of tree trunk halves. The massif at the chamber's south side remains and likely contains additional beams. The significant point is that the beams were contained and hidden within the massif. Therefore they could not play any symbolic or practical role in the burial and their purpose had to relate either to the construction or to the purpose of the massif.

Perring's drawings, one of Hussein's photographs, and possibly one of Fakhry's drawing all indicate that the south side of the upper chamber was filled with a sloping mass starting at the entrance and inclined up to the top of the massif. This might indicate a stairway was present at one time to access the top of the massif which was the real chamber floor. While there are no markings on the side walls to indicate a stairway, it would not be inconsistent with the structures in the chamber today or with the stairway in the lower chambers. In addition, the angled ceiling at the entrance to the upper chamber could have provided headroom for people using a staircase. While the presence of the staircase is not based on strong evidence, the existence of the large massif filling the room and raising the floor is a near certainty.
