THE OSTRACON

The Mortuary Temple of Hatshepsut at Deir el-Bahri: The Construction and Restoration of a Masterpiece—Part II

Bonnie M. Sampsell

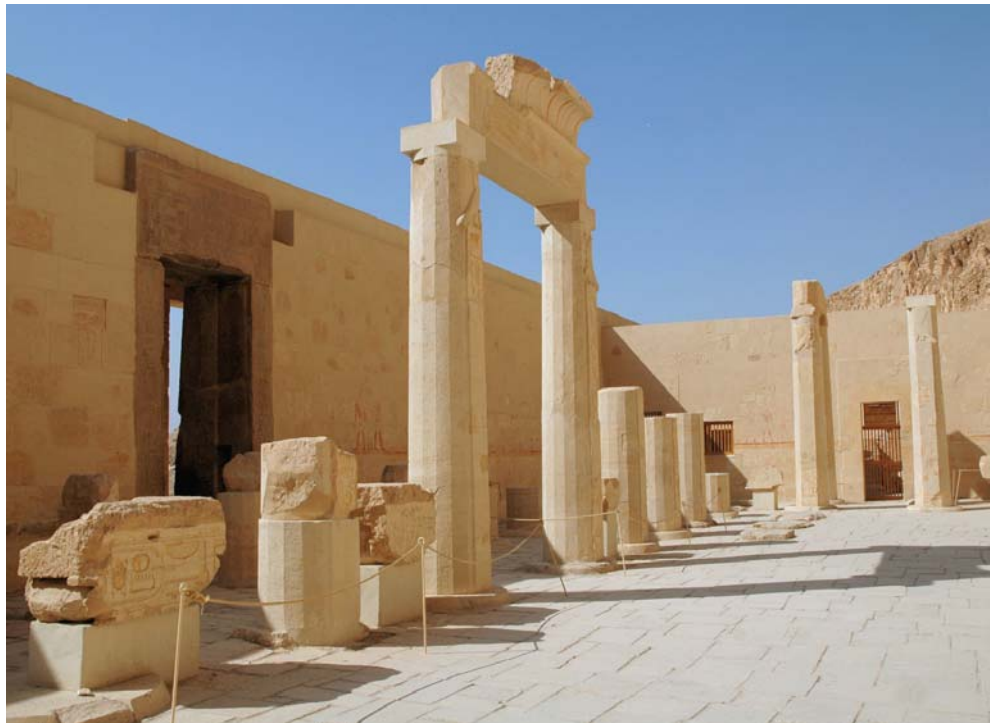
Fig. 1. Upper Courtyard looking towards southeast corner. Polygonal columns have been restored to various heights depending on the number of ancient fragments they contain. Some fragments of architraves are set on plinths (left front).

Some sections of Hatshepsut's temple have been rather fully restored, while in others—where only a small number of original fragments have been recovered—only a partial restoration has occurred. For example, only a handful of Osiride statues were reconstructed in the Upper Portico, and most columns in the Upper Courtyard are only a few feet tall—reaching only as high as the ancient fragment they contain (Fig. 1).⁸ Some original fragments have been judged too fragile or too valuable to remain in the temple and have been placed in museums. At the same time, replicas of some of the original material that has been removed to museums have been used in the restoration.⁹

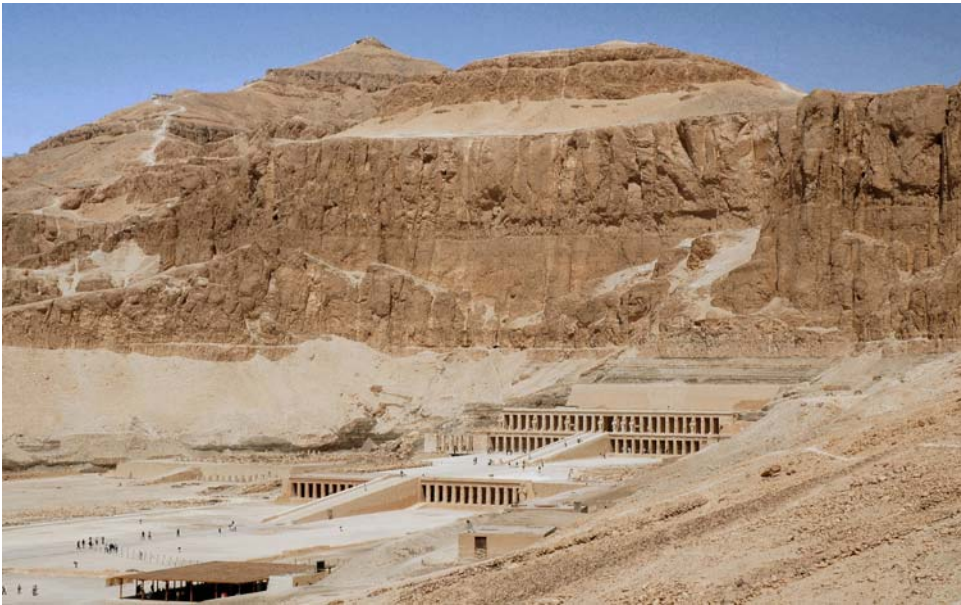
Fig. 2. Hatshepsut's Mortuary Temple at Deir el-Bahri lies beneath unstable cliffs of shale topped by massive limestone.

During all periods, ancient builders, excavators, and restorers at Deir el-Bahri have faced a major geological problem: the unstable nature of the rock in the cliffs behind and above the temples (Fig. 2).¹⁰ Weathered limestone falls in chips and chunks. Ancient rockfalls buried the temple ruins under many

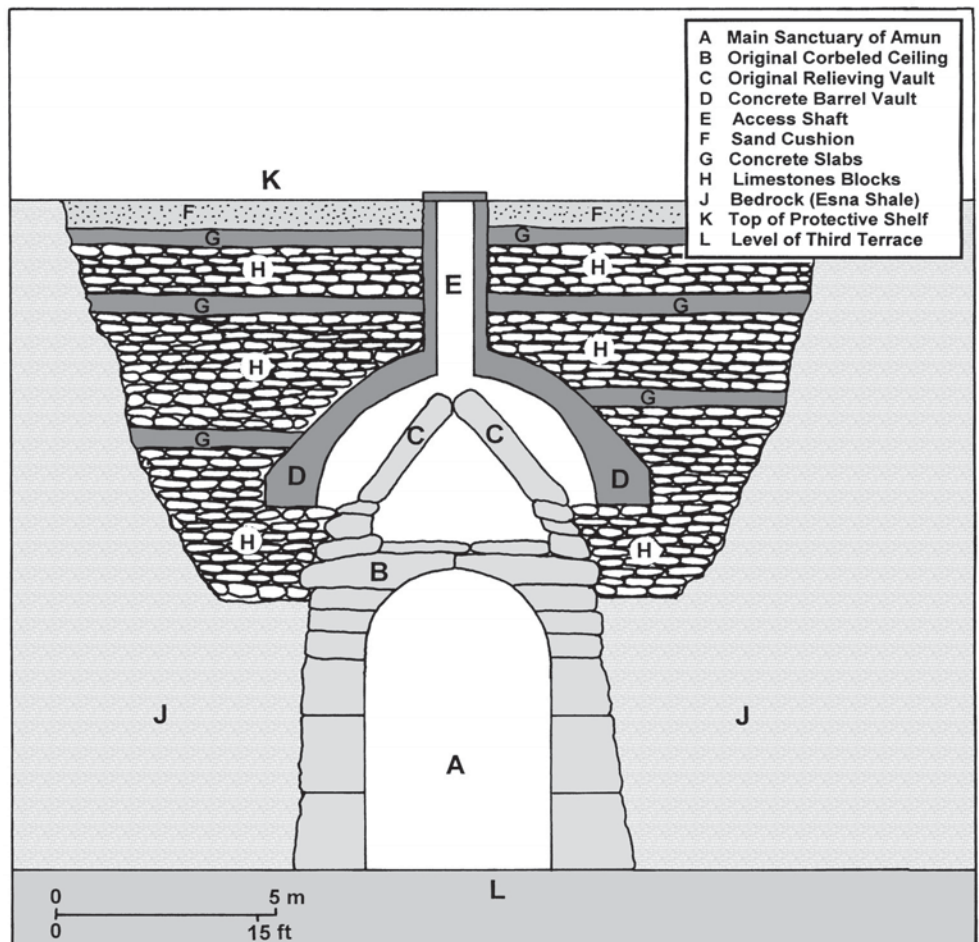
Fig. 3. Cross-section through Amun sanctuary (on Upper Terrace) showing ancient vault and modern reconstruction. (Based on Wysocki 1983.)

During the work on the platform an additional aspect of the original construction was revealed. The Amun sanctuary, which has the appearance of rock-cut chambers lined with fine limestone slabs, had in fact been built in a trench that was cut into the cliff. This trench extended from the top of the platform to the floor of the Upper Courtyard (Fig. 3, previous page). The sanctuary’s first chamber (the high-ceilinged barque chamber) was built of limestone blocks within this trench. Its ceiling was corbeled with more limestone blocks and then cut out from below to give the impression of a curved vault.¹⁴ Above this ceiling, a relieving vault was created by pairs of leaning gable blocks. Then the trench was refilled to the level of the platform. Wysocki found evidence that this was actually a remodeling of Tuthmosis II’s original rock-cut sanctuary ordered by Hatshepsut.¹⁵

The original ceiling blocks and relieving vault blocks were in excellent condition. But to protect them, Wysocki obtained permission from the Egyptian authorities to erect a reinforced-concrete barrel vault above the ancient relieving vault before refilling the trench. A shaft was built to provide access to the interior of the barrel vault from the restored platform above so that the ancient construction can be examined in the future.
